INDUSTRY RESEARCH REPORT

Indoor Coil Corrosion

IDENTIFYING COMMON SOURCES

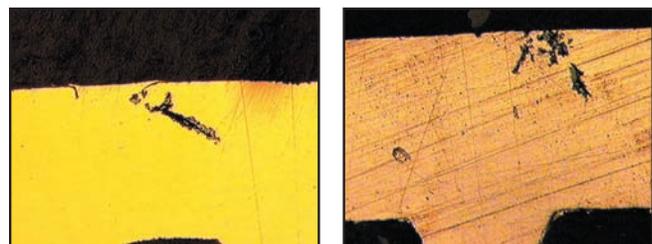
This issue exists industry-wide. A competitive study has shown identical corrosion failure leaks in all coil brands investigated. The photos at right show magnified tubing cross-sections from failed coils. The progression of the corrosion is from the exterior of the tube inward, eating away at the copper, until penetration occurs and a leak results! **Due to the corrosion process, some photos look better than others, but all corroded through the tube causing a leak at that point. All coils failed in the time period characteristic of such a failure.**
